Railways and materials: synergetic progress

Roderick A Smith*

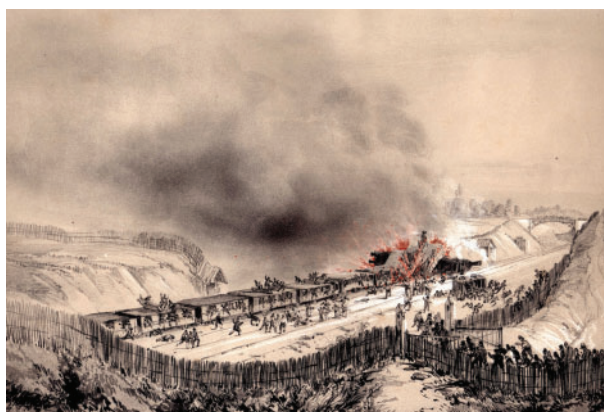
3 The accident on the Paris Versailles Railway in 1842

Many investigations were prompted by the accident on the Paris to Versailles Railway in 1842 (Fig. 3).¹ This accident, caused by the derailment of an engine due to a broken axle, led to flimsy wooded carriages, with the helpless passenger locked inside, piling up on the wreckage of the engine and being set on fire by the spilt burning coals. Upwards of 70 persons were killed*, the first time a railway accident had caused major loss of life, and the news was a sensation throughout Europe and America.

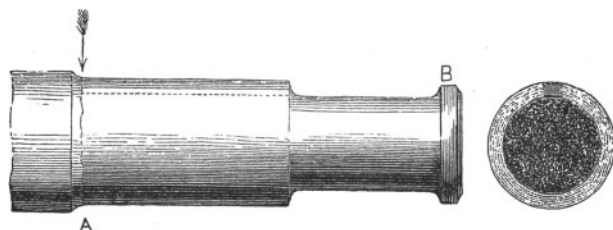
4 A typical axle failure of the 1840s. The shoulder of the axle caused a stress concentration at which the fatigue crack grew

It was recognised that axles suffer a great many repeated stress cycles as they rotate and in the early days many fanciful theories were proposed to explain why failures occurred after periods of successful service. Popular amongst these were changes in the internal structure of the metal, so-called 'crystallisation' (for an explanation of why this erroneous idea took root, the reader is referred to the brief Appendix on the metallurgy of iron and steel). The more astute and careful observers of fractures, recognised the deleterious effect of stress concentrating features (Fig. 4), but it was to be over a century

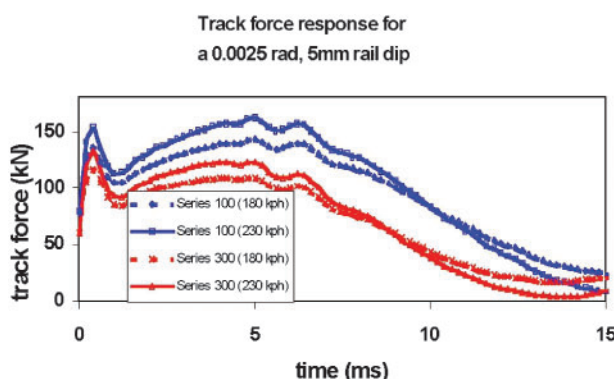
5 Dynamic forces produced by the passage of trains over a rail head geometry defect

An example, calculated using a simple model from data supplied by the Japanese Central Railway Company is shown in Fig. 5, which illustrates the forces generated as a function of time by the passage of a train over a small (5mm) dip in the rail head. Two trains

are shown, an old type (Series 100) and its replacement (Series 300). The intention was to increase the speed of operation from 180 to 230 km h⁻¹. The form of the response from both trains at both speeds is similar: with the dynamic forces showing two clear peaks with time, the so-called P₁ and P₂ forces. The dynamic magnification increases with speed and lies in a range approximately 2.5–3 times greater than the static force. Clearly these magnified forces have a significant effect on the fatigue of wheels, rails and axles. They are significant too in their effect on track maintenance. This is summarised on Fig. 6, which is a representation of the typical track maintenance costs as a function of speed for both types of train. The important characteristics of the new train are shown: a smaller wheel load (reduced from 7.5 to 5.7 t) and a smaller unsprung mass (reduced from 2.3 to 1.7 t), the reduction of which is a particularly sensitive way of reducing dynamic track forces. In the example shown, if the old train had been run at the required higher speed of 230 km h⁻¹, the track maintenance costs would have increased by some 20%. However, the new lighter train

produces a saving of some 10% even at the higher speed. Obviously this is a somewhat simplified view of a complex situation which depends on many parameters. However, it serves to capture the essence of the dynamic load problem and illustrates the need for track and train designers to work in conjunction with each other. It serves also to illustrate the constraint of higher speeds and structural integrity. For high speeds it is necessary to drive down mass in critical components thus making them more prone to fatigue.

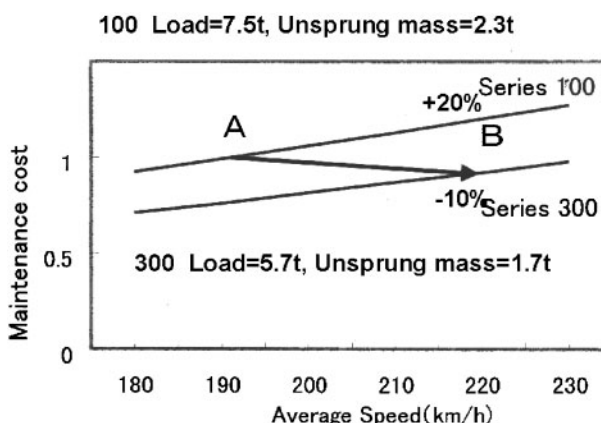
6 Generic effect of dynamic forces on maintenance costs

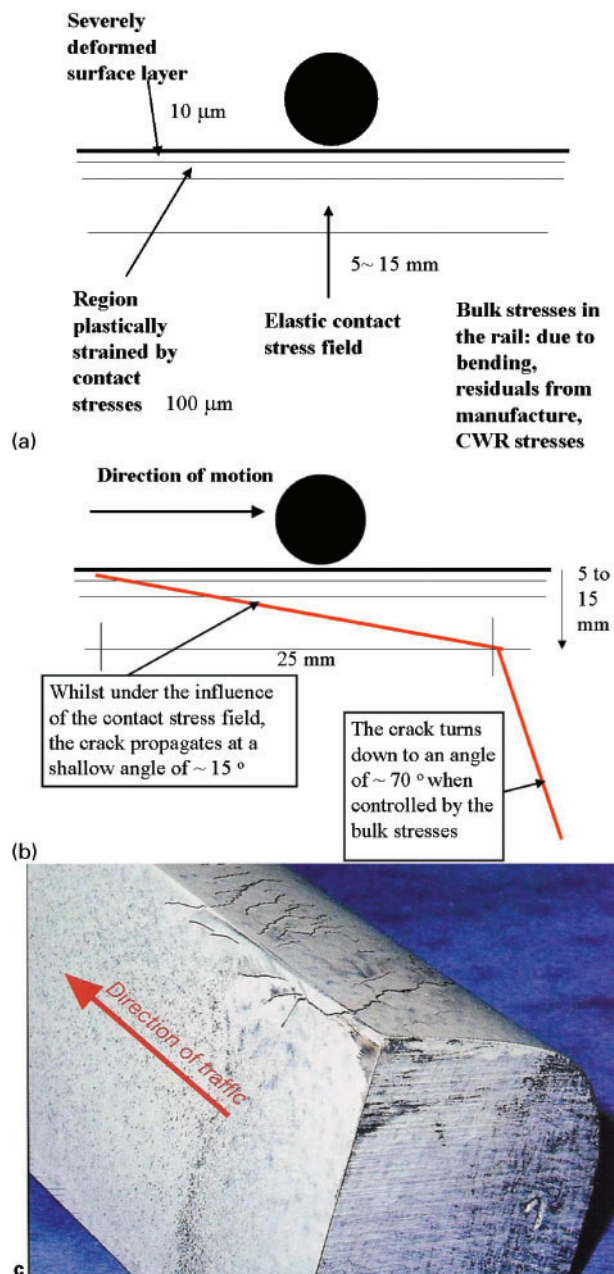
7 a. Depth of stressed zones, b. Geometry of crack propagation, c. Sectioned rail head showing crack development

stress to the contact zone stress to the bulk stress (Fig. 7 a,b). This type of behaviour is paralleled in other fatigue situations when cracks initiate in high surface stress fields at, for example, sharp geometric notches, fretting patches and thermally loaded surfaces. In both wheels and rails, cracks can turn back upwards towards the surface leading to the formation of a detached flake (spalling).

grow down into the railhead. The cracks progress at a slow rate from the running surface, typically inclined downwards at a shallow angle of some 10°, until some 5 mm below the surface (Fig. 7c) they branch. If the branch crack propagates upwards, driven by plastic deformation of the thin tongue of metal above the crack, a part of the rail surface detaches or spalls – a form of damage that is clearly visible on inspection. But more dangerously, some cracks turn downwards into the head of the rail and these branches are extremely difficult to detect by conventional ultrasonic inspection techniques. It is claimed that eddy current methods may be more reliable,

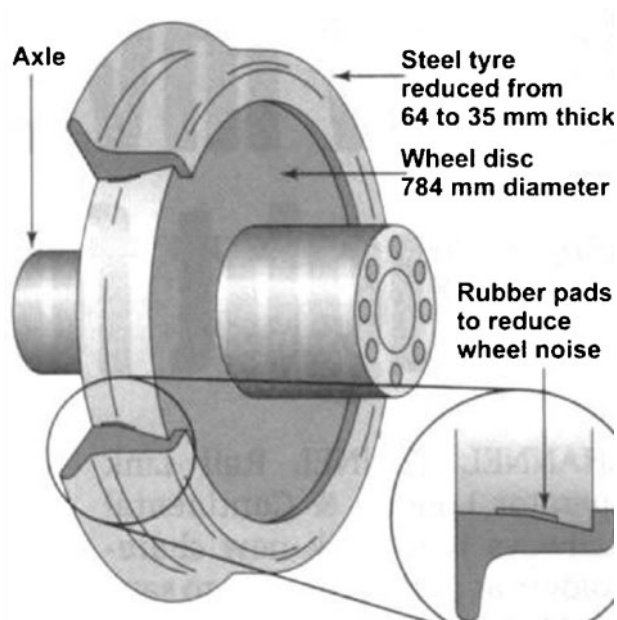
8 Construction of the resilient wheel which failed at Eschede 23 June 1998

The much-publicised accident to the German ICE train on 23 June 1998, which resulted in more than 100 fatalities, was caused by a fatigue fracture on the underside of a wheel rim separated from the disc of the wheel by rubber pads (Figs. 8 and 9).

This design, much used on vehicles operating at lower speeds, has the supposed advantage of reducing the transmission of noise and vibration from the wheel/rail contact into the body of the vehicle. The so-called resilient wheels were put into service without, in the author's opinion of the evidence available to him, adequate

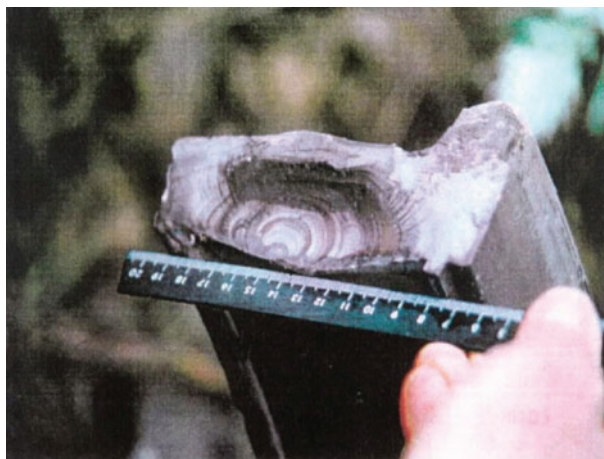
9 The failed tyre (rim) of the Eschede wheel. The fatigue crack is self evident

failure, therefore the site of potential failure was unknown and not adequately covered by the inspections. The root cause of this disastrous failure was not lack of fatigue knowledge, but the inability to anticipate a problem caused by a flexible wheel of significantly different design from a standard wheel, compounded by inadequate testing prior to the introduction of a the new design into service.
